📅 THURSDAY, OCTOBER 14, 2021

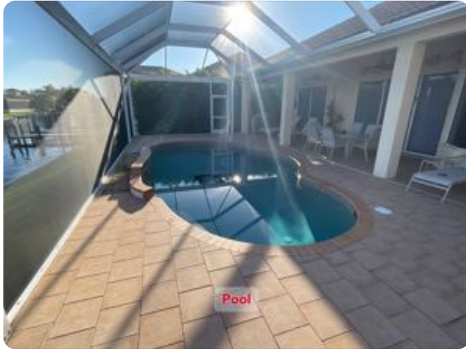
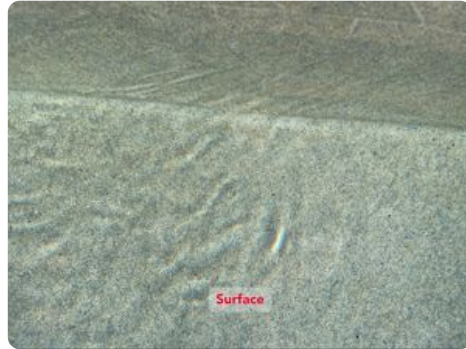
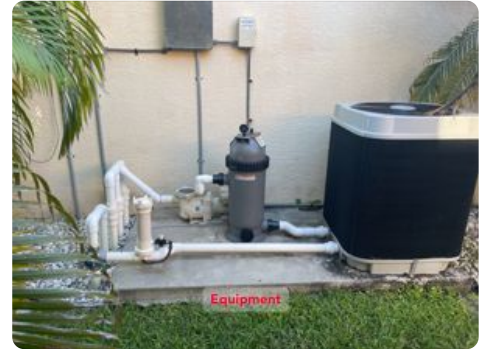
Deck/Surface/Equipment

Deck: Tile Surface:blue gem Picture of pool equipment.

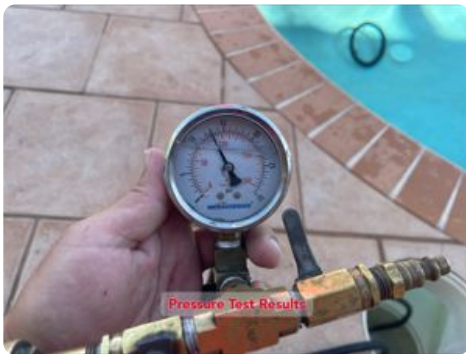
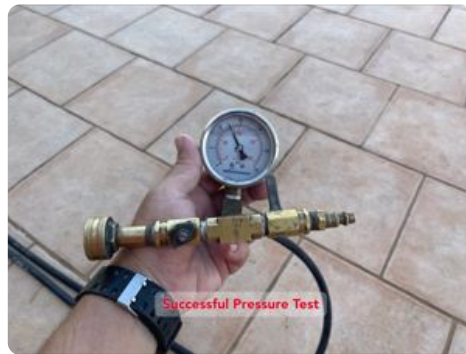
Test - Pressure Test - Leak Detection

Pressure tested all lines. All lines appear to be holding solid.

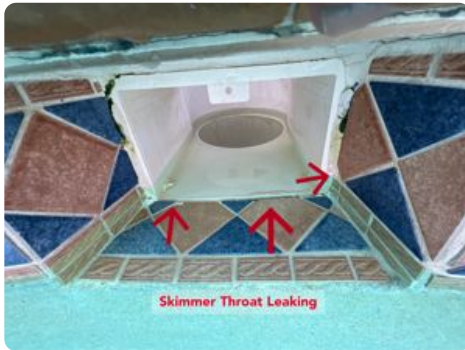
Pool - Skimmer - Throat

Found leak in skimmer throat where the plastic skimmer butts up to the cement pool shell. Area had been previously epoxied and the deterioration is now severe and over a quarter inch wide in some areas. Tried to Patch with epoxy but patch kept pulling into the gap. I do not expect this to hold. Expect minimal water loss until repairs are completed. Recommend skimmer throat rebuild. Using surface to replace the inner tiles as we will not be able to match the current tiles and using surface is the better repair.

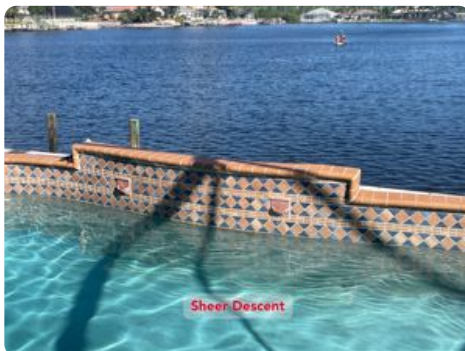
Pool - Sheer Descent (unable to test)

The sheer descent(s) CANNOT be tested because there is no way to plug off it's long, narrow opening.

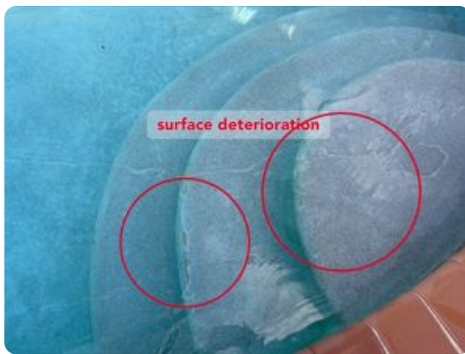
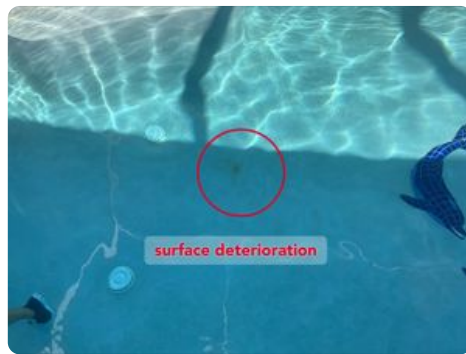
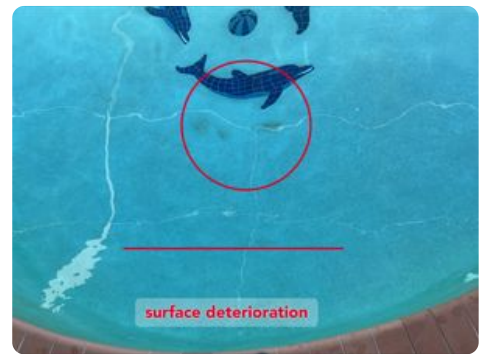
Miscellaneous

Surface is showing signs of deterioration.
