📅 WEDNESDAY, MAY 19, 2021

## Test - Pressure Test - Leak Detection

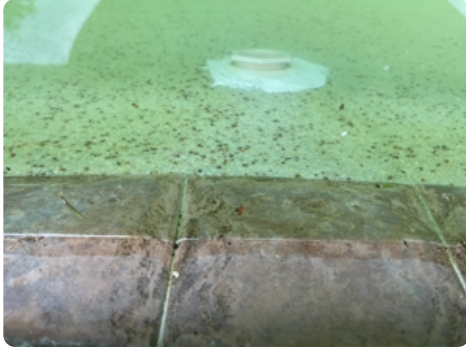
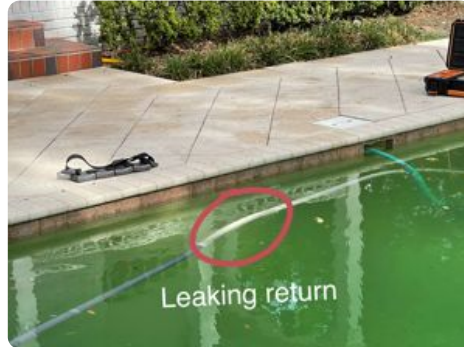
## Pool - Return (around)

Found leak around pool return. Patched with epoxy. Recommend proper repair.

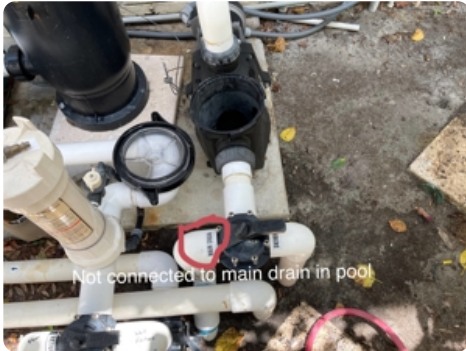
## Miscellaneous

Pipe labeled main drain on pool pump may actually be a waste line. Didn't purge air into pool.

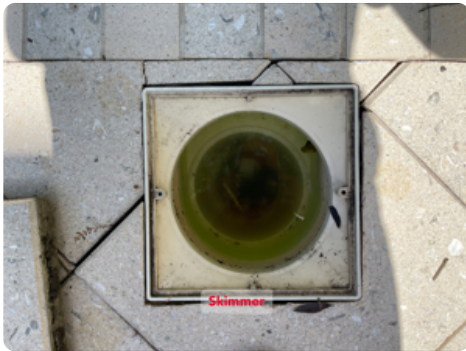
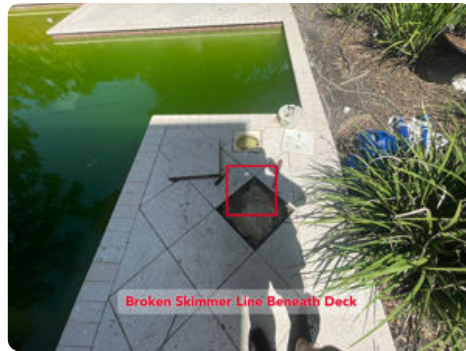
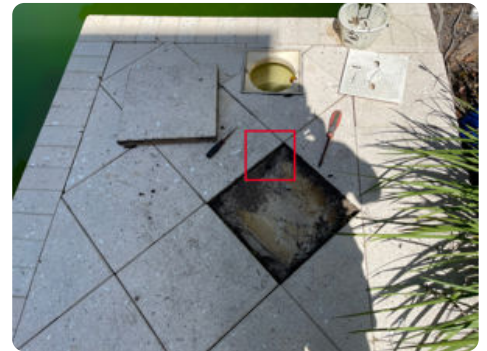
### Pool - Skimmer - Broken Line - Deck

Found broken skimmer line under the deck. Marked deck with photo. Needs to be repaired. Plugged off skimmer pipe and shut off at valve to prevent further water loss.
