📅 WEDNESDAY, SEPTEMBER 29, 2021

Deck/Surface/Equipment

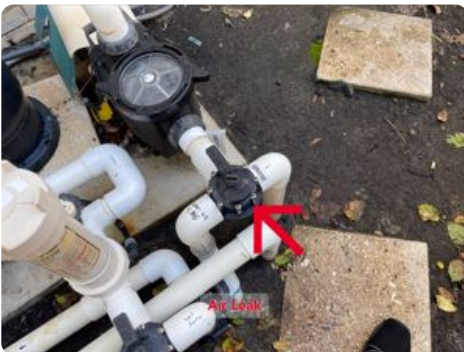
Equipment - Valve - Air Leak

Found air leak at valve. When pump is running, air is entering through the skimmer Jandy valve needs to be serviced. See picture for dysfunctional valve.

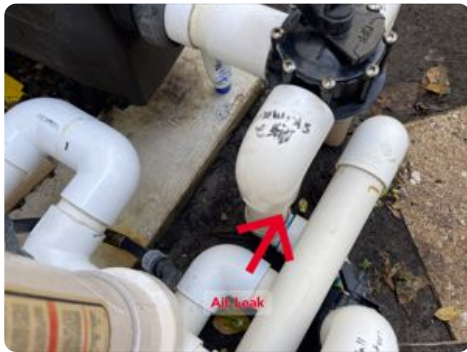
Equipment - Fitting - Air Leak

Found air leak at suction side elbow. When pump is running, air is entering the system through elbow. Fittings need to be replaced. See picture for dysfunctional fitting.

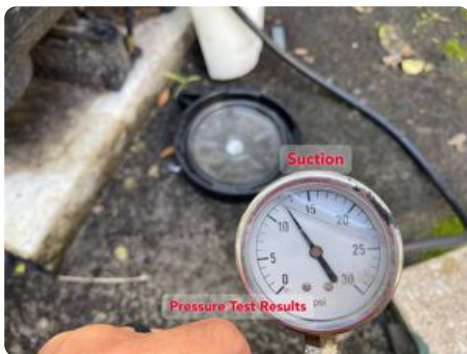
Test - Pressure Test - Leak Detection

Pressure tested all lines. All lines appear to be holding solid.

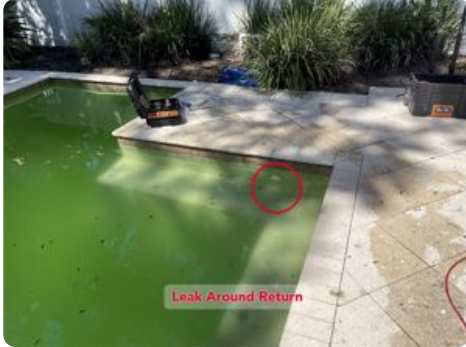
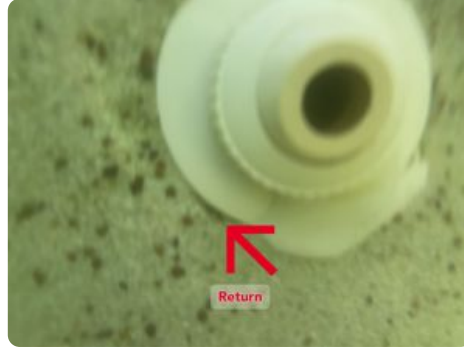
Pool - Return (around)

Found leak around pool return. Patched with epoxy. Recommend proper repair.

Epoxy was applied as a temporary patch to the leaking skimmer throat and pool return so that it can be ensured all leaks have been identified and all appropriate repairs have been quoted.

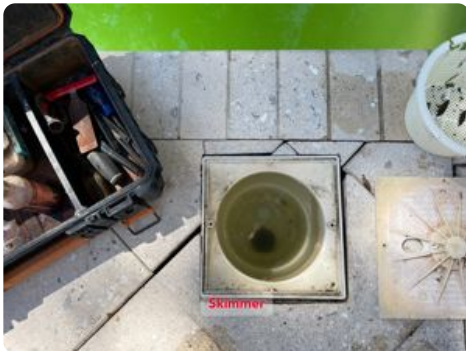
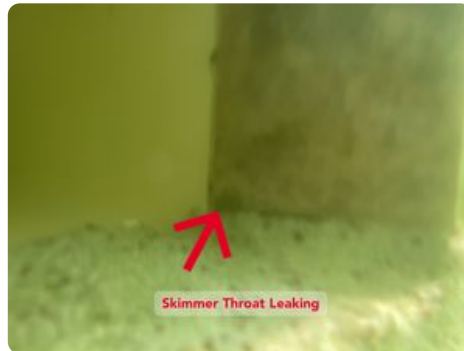
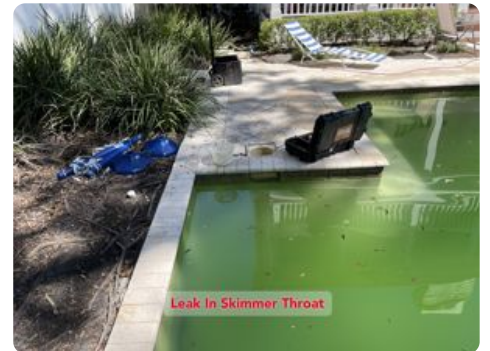
Pool - Skimmer - Throat

Found leak in skimmer throat where the plastic skimmer butts up to the cement pool shell. Patched with epoxy. Recommend proper repair.
