📅 TUESDAY, OCTOBER 12, 2021

## Deck/Surface/Equipment

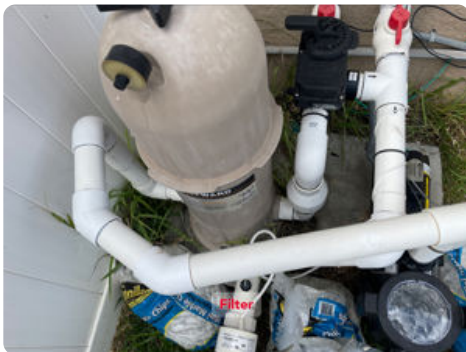
## Equipment - Filter

Found leak coming out of filter when pump is running. &nbsp;  Filter needs to be serviced. &nbsp;

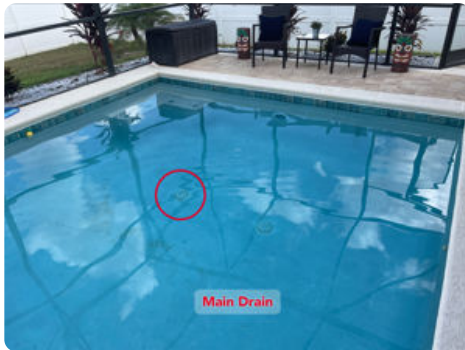
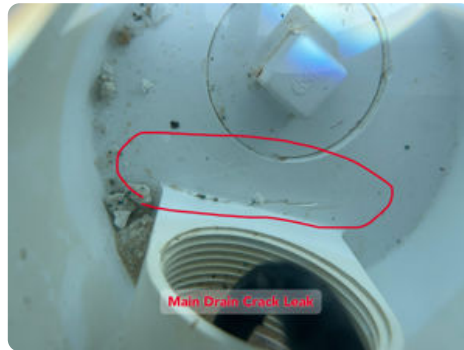
## Pool - Main Drain - Sump (crack)

Found leak in cracked pool main drain sump. Needs to be replaced.&nbsp;

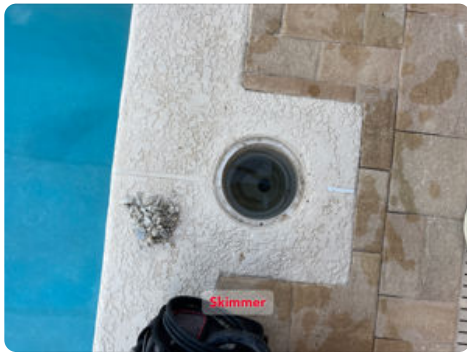
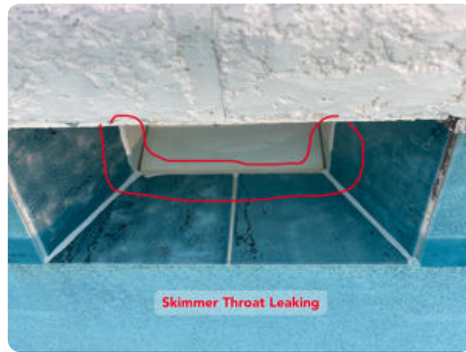
## Pool - Skimmer - Throat

Found leak in skimmer throat where the plastic skimmer butts up to the cement pool shell. Patched with epoxy. Recommend proper repair.

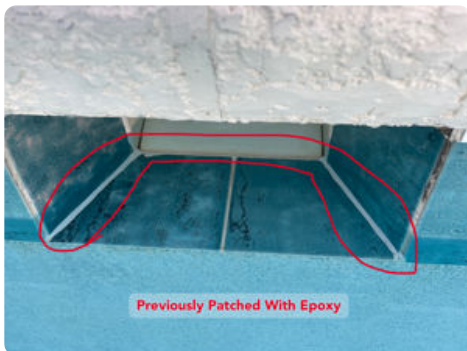
## Epoxy - Item Previously Epoxied

Found existing epoxy patch (in/around) (skimmer throat). Epoxy patches are an indication of previous leaks that could open up in the future as the patch wears away, initiating further water loss. Recommend proper repair.

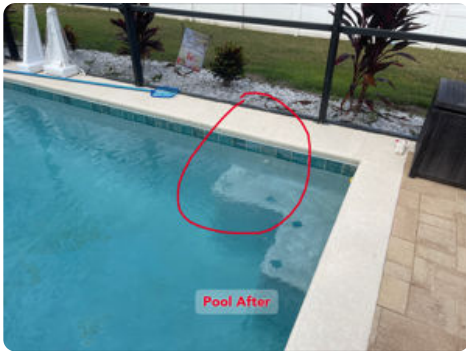
## Miscellaneous

When specialist arrived on site. Air bubbles were exiting pool side. Specialist recommends consulting your pool service provider to service jandy/ pump to make sure all seals are good and tight. Air is entering through either pump or jandy valves. Result solar panels are allowing air to enter system. When off no bubbles.
