📅 MONDAY, JANUARY 9, 2023

Deck/Surface/Equipment

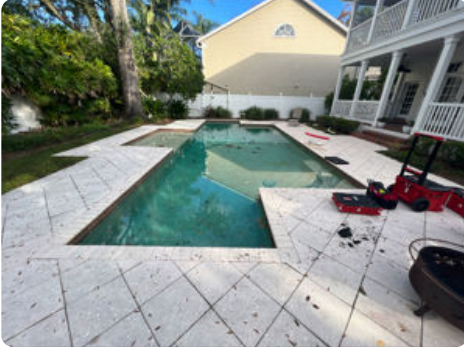
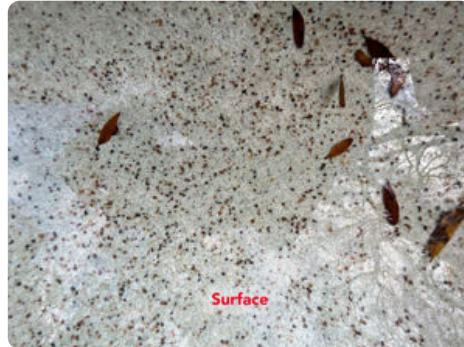
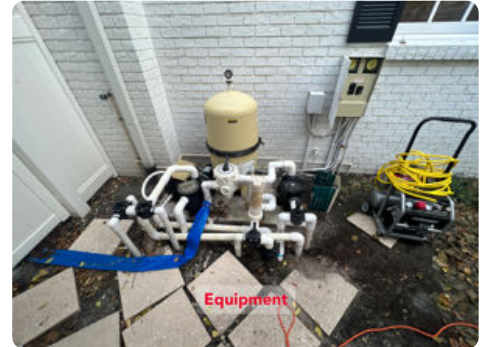
Deck:PaversSurface:Pebble tech

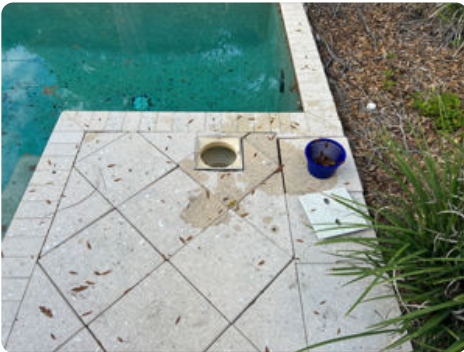
Miscellaneous

Noticed that the ground/ Pavers near a previous skimmer repair was very uneven.

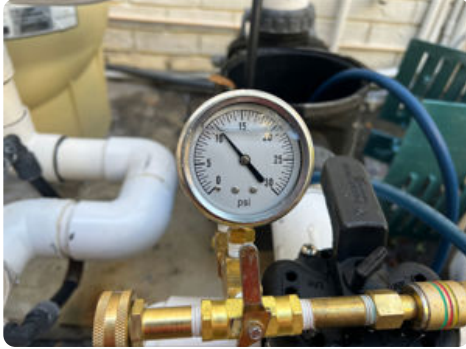
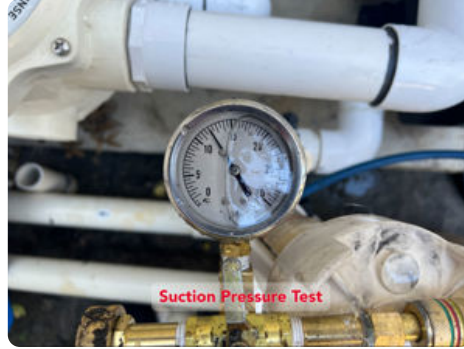
Test - Pressure Test - Leak Detection

Pressure tested all lines. All lines appear to be holding solid.

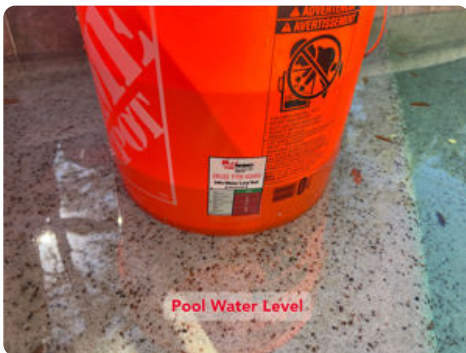
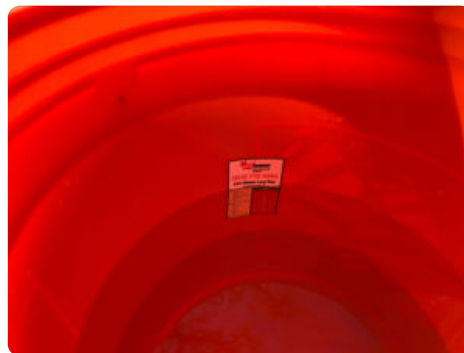
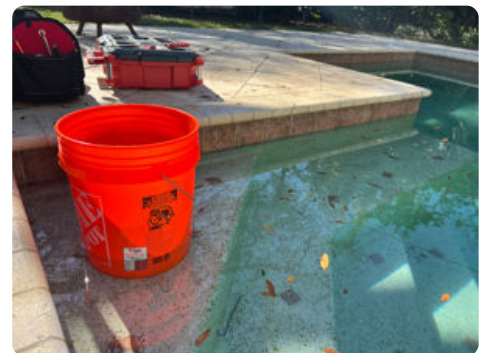
Test - Water Loss - Set Up

Test - Complete Dye Test

Performed a complete dye test in the pool. Everything appears to be solid.

Water level marked in: Outside Bucket and inside bucket Results will be confirmed by: Visit
Date of confirmation: 2023-01-10 Additional Notes: Unable to locate leak, set up water loss

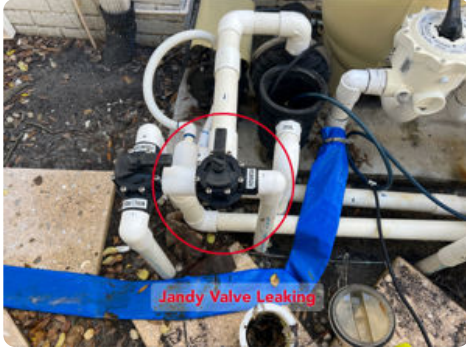
Equipment - Valve - Water Leak

Found leak coming out of return jandy when pressure testing line. Jandy needs to be repaired.

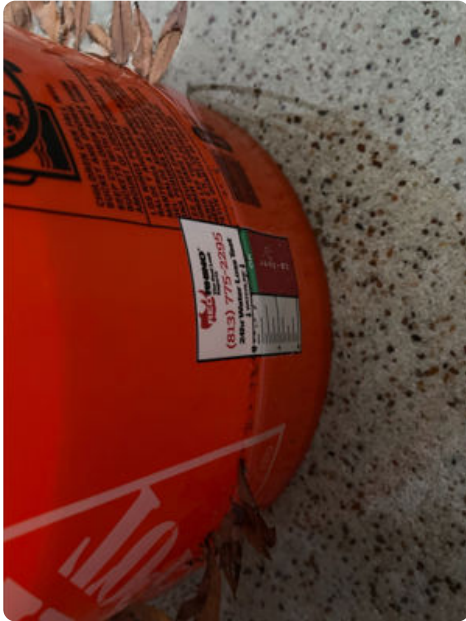
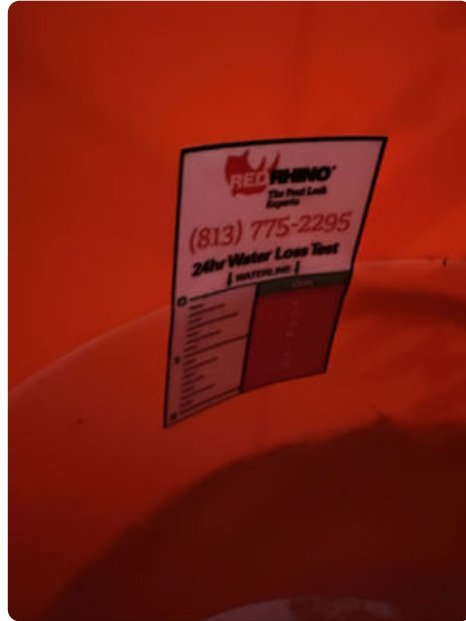
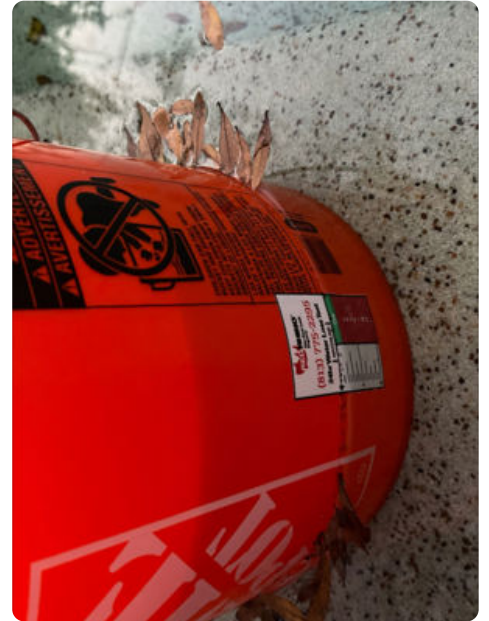
Test - Water Loss - Results - Not Leaking

Confirmed water level is holding solid. The water level is not leaking at a significant rate after 24hr water loss test.

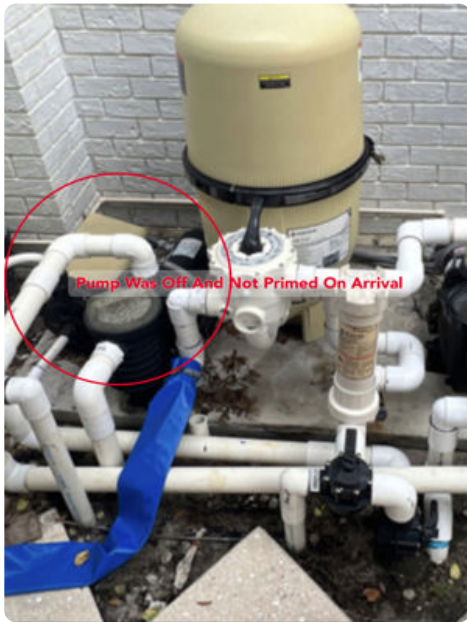
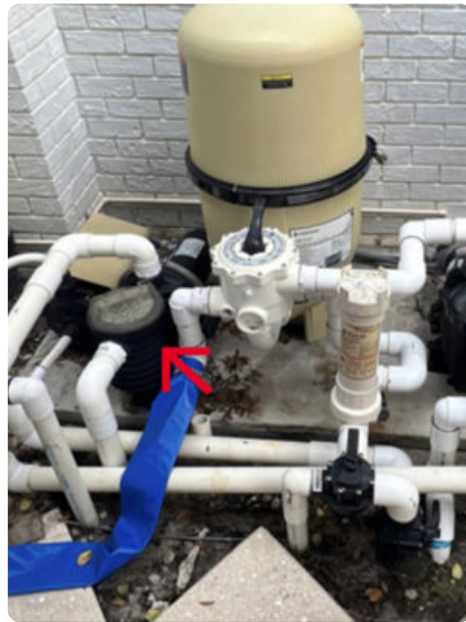
Problems - Pump (not working upon arrival)

The Pump that controlled the water feature was not working or primed upon arrival. Pump needs to be serviced along with Jandy valve already noted in findings.
