Invoice

Pool Leak #207684

[®] The Pool Leak
Experts

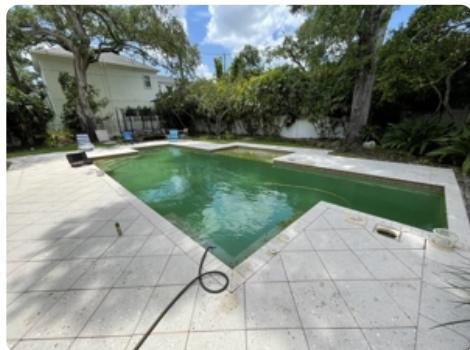
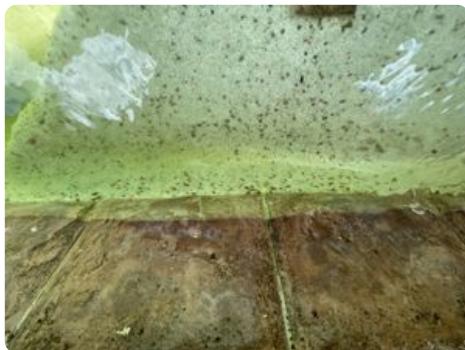
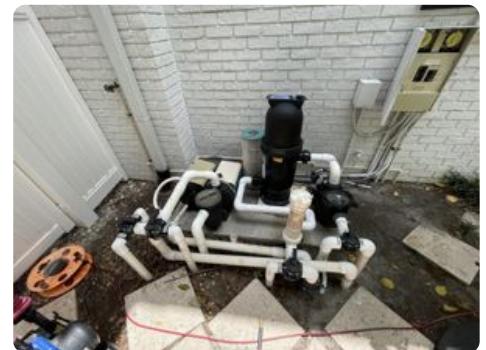
Deck/Surface/Equipment

Description of deck and surface. Deck: Pavers Surface: Brown/Gold Pebble Tech Picture of pool equipment.

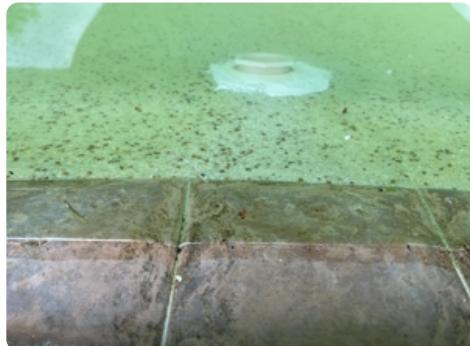
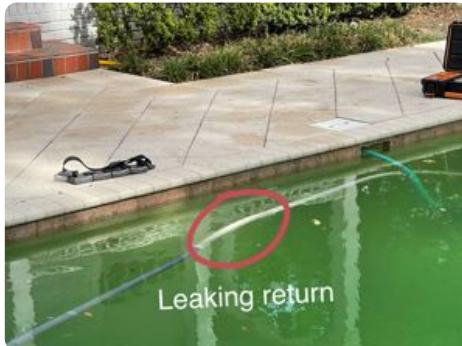
Pool - Return (around)

Found leak around pool return. Patched with epoxy. Recommend proper repair.

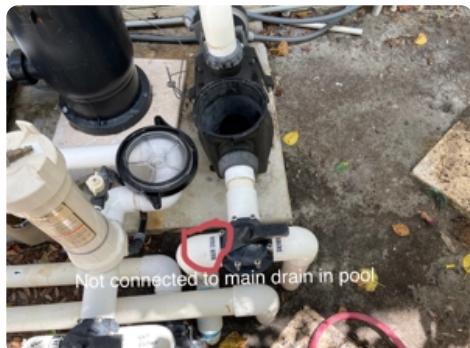
Miscellaneous

Pipe labeled main drain on pool pump may actually be a waste line. Didn't purge air into pool.

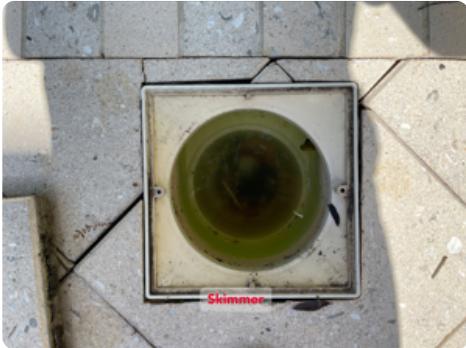
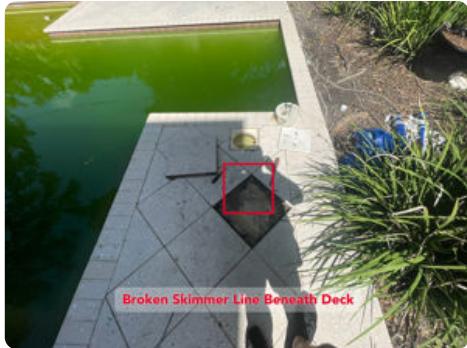
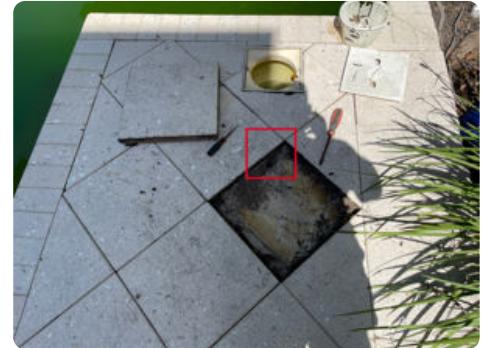
Pool - Skimmer - Broken Line - Deck

Found broken skimmer line under the deck. Marked deck with photo. Needs to be repaired. Plugged off skimmer pipe and shut off at valve to prevent further water loss.
