Pool Leak #228118

The Pool Leak
Experts

WEDNESDAY, SEPTEMBER 29, 2021

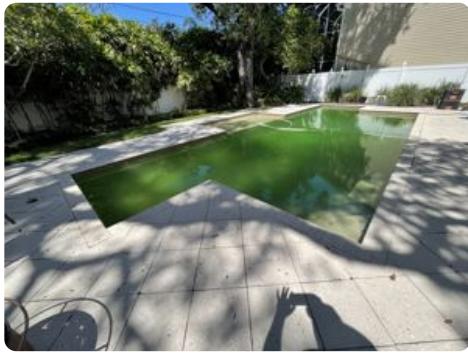
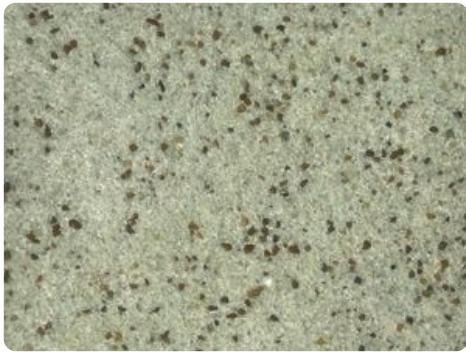
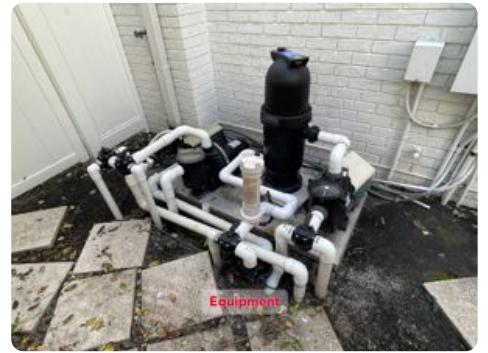
Deck/Surface/Equipment

Description of deck and surface.

Deck: Travertine Pavers

Surface: Bone Gem Picture of pool equipment.

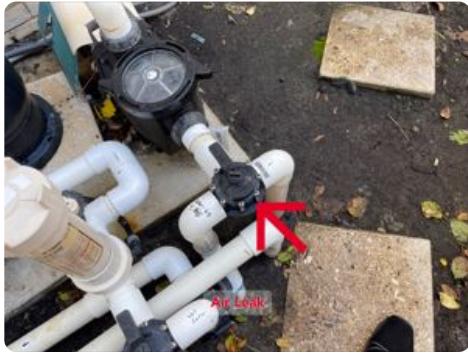
Equipment - Valve - Air Leak

Found air leak at valve. When pump is running, air is entering through the skimmer Jandy valve needs to be serviced. See picture for dysfunctional valve.

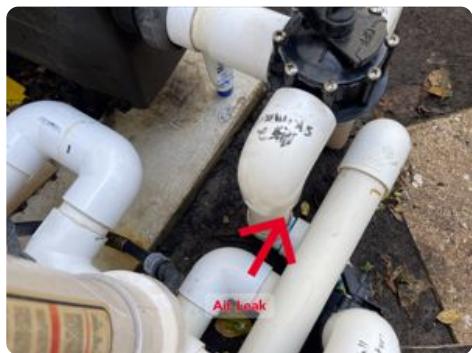
Equipment - Fitting - Air Leak

Found air leak at suction side elbow. When pump is running, air is entering the system through elbow. Fittings need to be replaced. See picture for dysfunctional fitting.

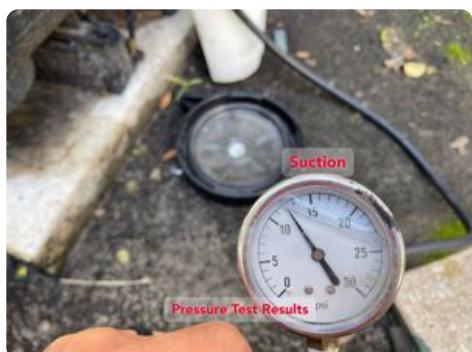
Test - Pressure Test - Leak Detection

Pressure tested all lines. All lines appear to be holding solid.

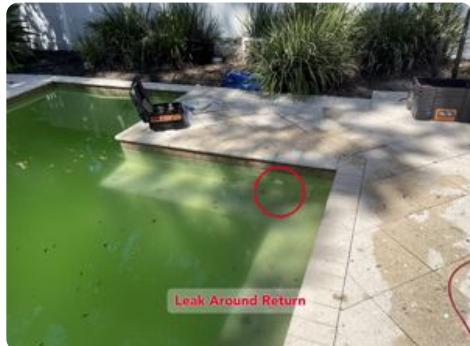
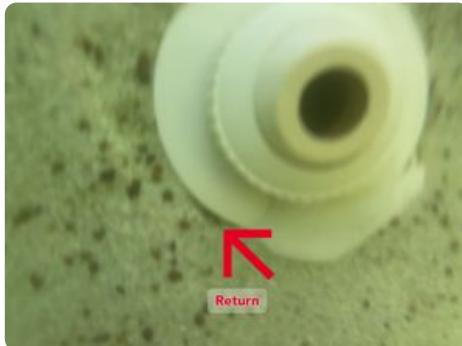
Pool - Return (around)

Found leak around pool return. Patched with epoxy. Recommend proper repair.

Epoxy was applied as a temporary patch to the leaking skimmer throat and pool return so that it can be ensured all leaks have been identified and all appropriate repairs have been quoted.

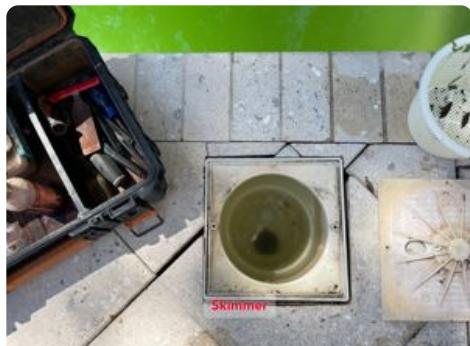
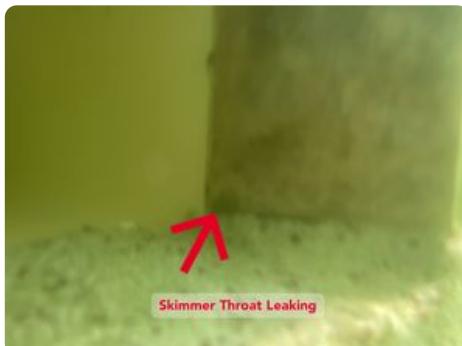
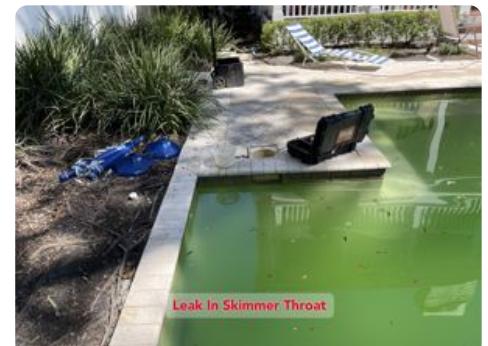
Pool - Skimmer - Throat

Found leak in skimmer throat where the plastic skimmer butts up to the cement pool shell. Patched with epoxy. Recommend proper repair.
