Invoice

Pool Leak #467741

The Pool Leak
Experts

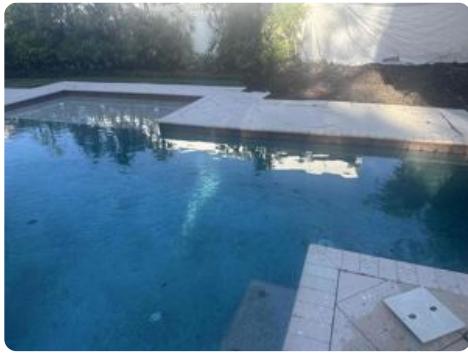
Test - Complete Dye Test

Performed a complete dye test.

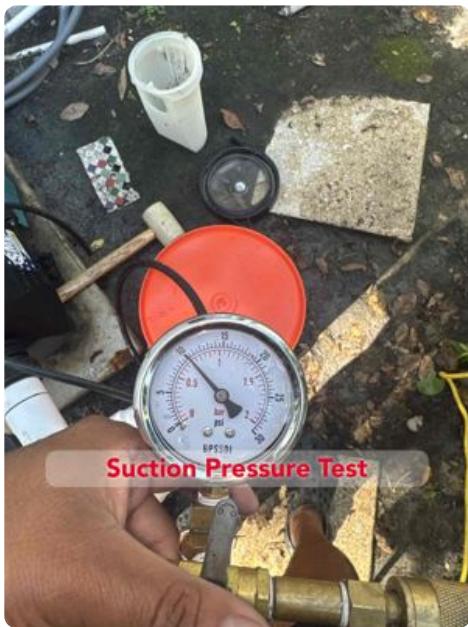
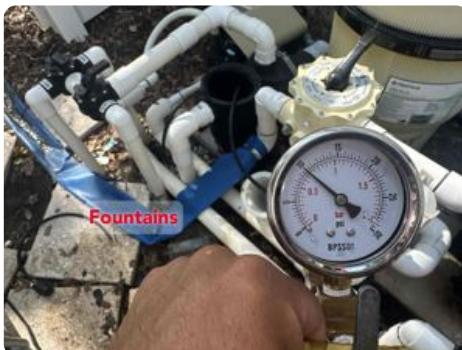
Test - Pressure Test - Leak Detection

All lines are holding solid
Additional Notes: Alternative testing on all returns Passed

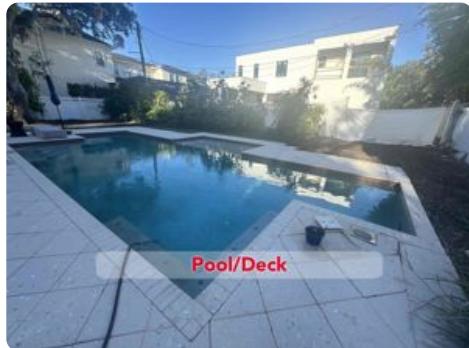
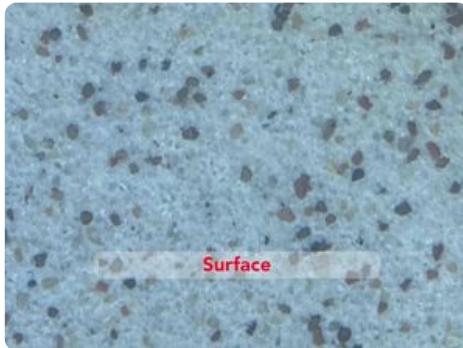
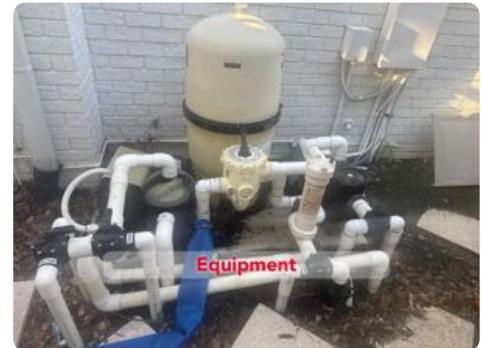
Deck/Surface/Equipment

Deck:Pavers Surface:Pebble tec

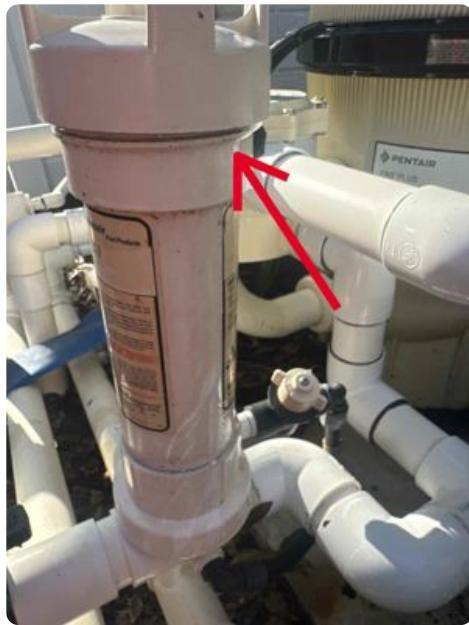
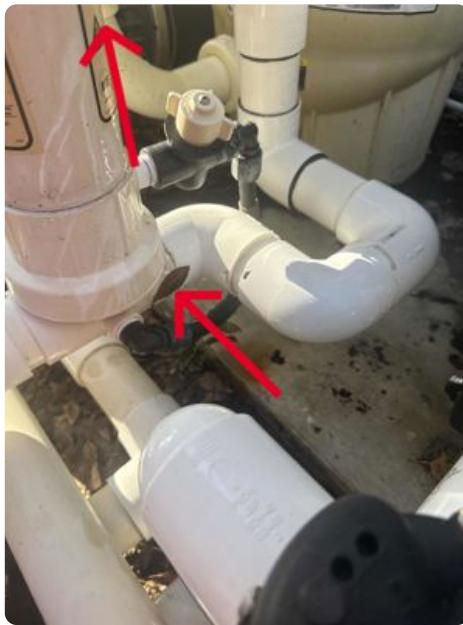
Leak Status - Equipment Leak

The equipment will leak, as identified in the findings, until it is fixed by a pool service professional.

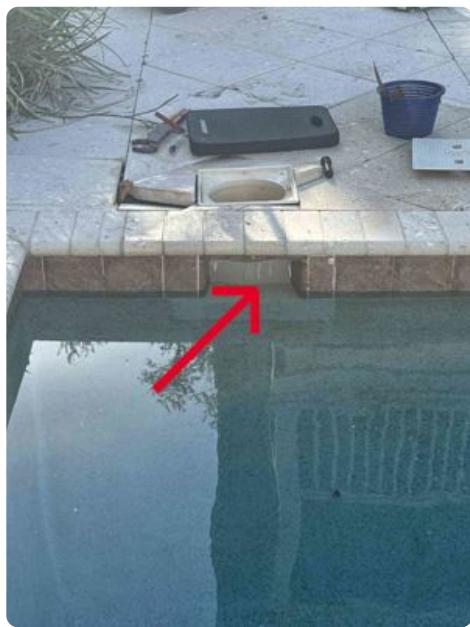
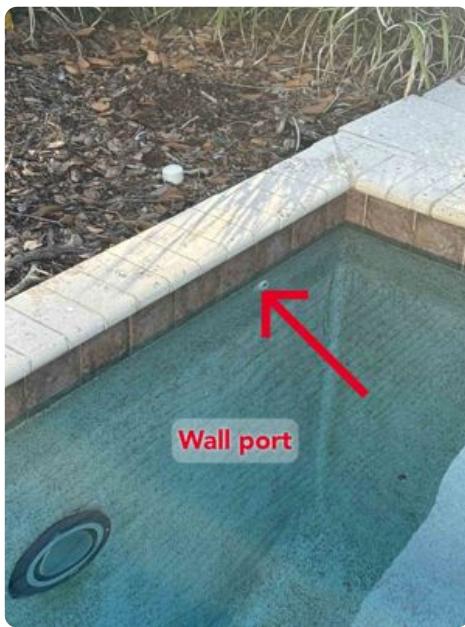
Epoxy - Item Previously Epoxyed

Found existing epoxy patch: In and around the light Around the return In the tile In and around the vac line Epoxy patches can be an indication of previous leaks that could open up in the future, initiating further water loss. Epoxy patches are an indication of previous leaks that could open up in the future as the patch wears away, initiating further water loss. Recommend proper repair. Additional Notes: Wall port closed with Epoxy

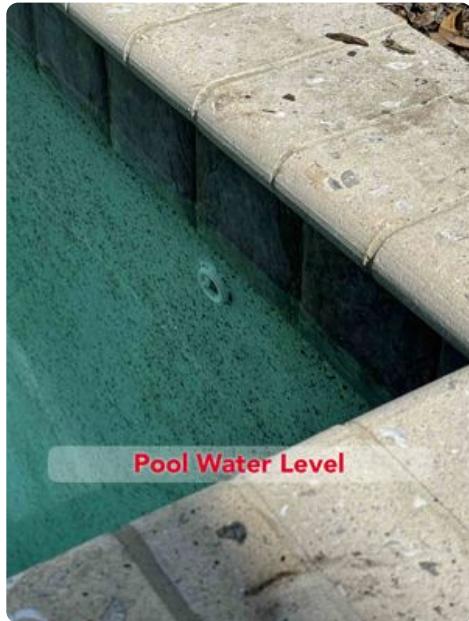
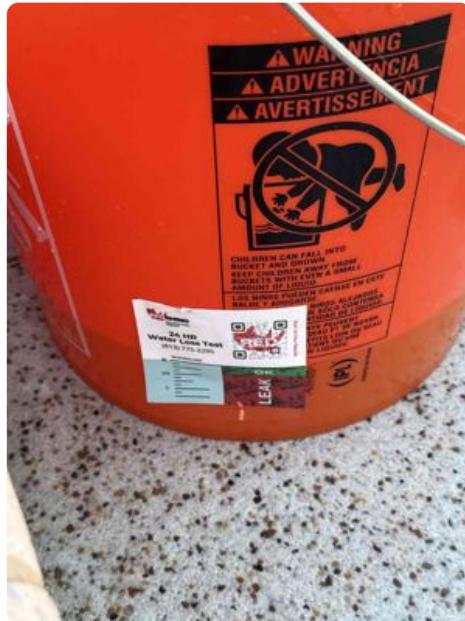
Pool Water Level

Water level marked in: Zero Results will be confirmed by: Phone call Date of confirmation: 2025-05-15 Additional Notes: Pump off

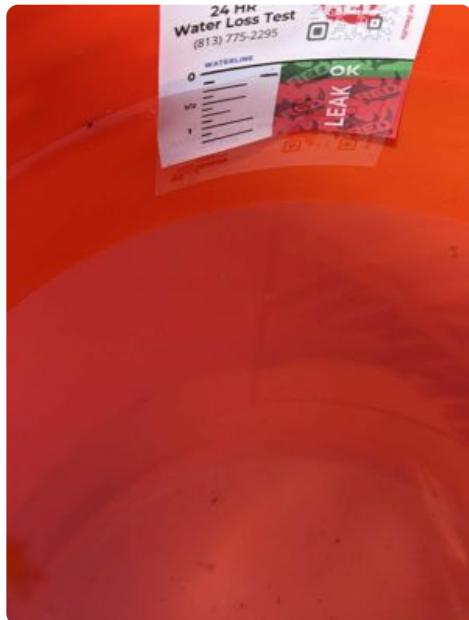
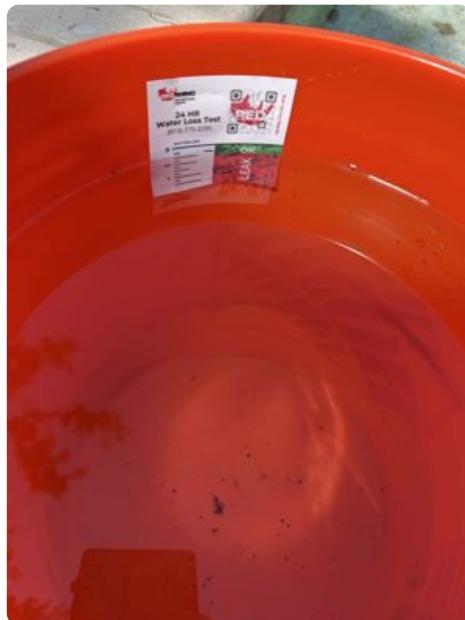
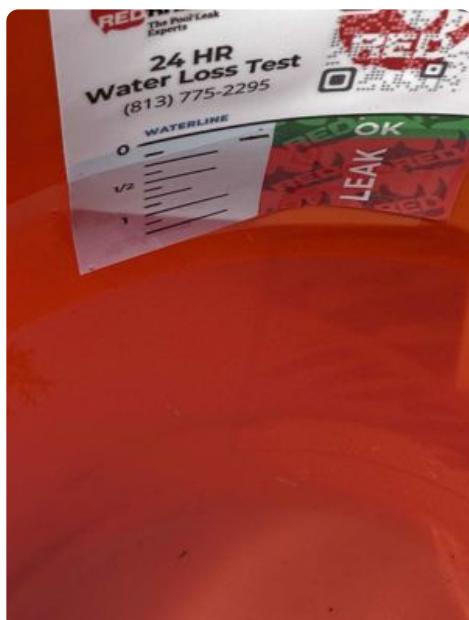
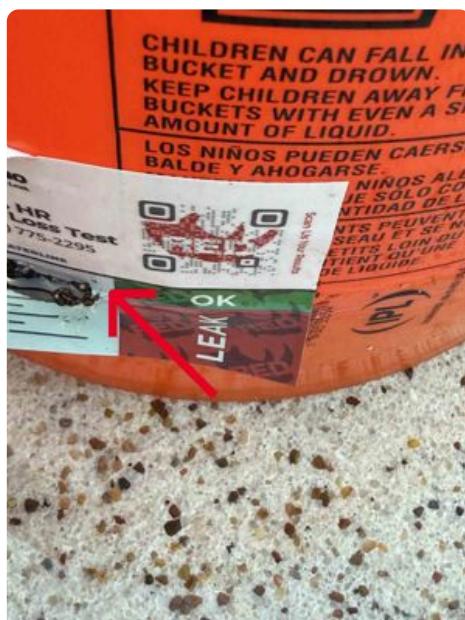
Test - Water Loss - Results - Not Leaking

Confirmed water level is holding solid. The pool is not leaking. Evaporation and equipment leak.
